# Manhole Inspection Summary

Manhole # **S13GG\_056MH**

Insp Date: **2/23/09 2:45 PM**

**Location** Address: **1618 POPLAR GROVE DR**

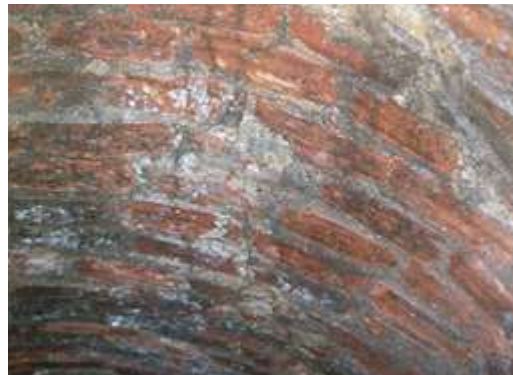
Defect 2

Condition: ☐ Sound ☒ **Cracked** ☐ Root Intrusion ☐ Loose Brick ☐ Deteriorated

CRACKED CORBEL

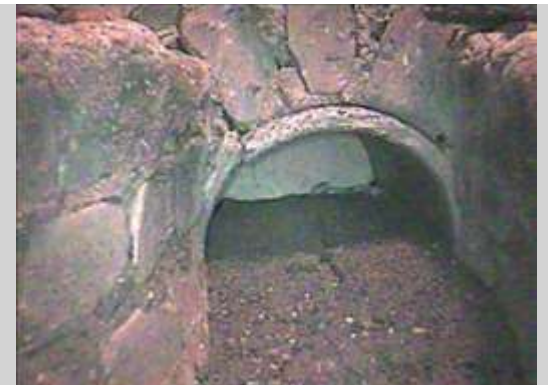
3 O'Clock Inflow

Pipe Height: (in.) Direct  
Pipe Material: **Clay** ☐ Pipe Lined  
Invert Depth: **7.82** (ft.) Flow Characteristics: **Slow**  
Deposits: ☒ None ☐ Mud ☐ Sludge ☐ Debris ☐ Grease  
Silt Depth: (in.) Deposits Extent:  
Infiltration: **None** Pipe Seal Cond: **Cracked**

Connects To: **Stub connection / abandoned**
